### Biwater

Biwater Treatment Ltd achieves a positive result to a negative transient pressure challenge.

Biwater Treatment designed and installed a pressurised filter and membrane plant at Broadford water treatment works (WTW).

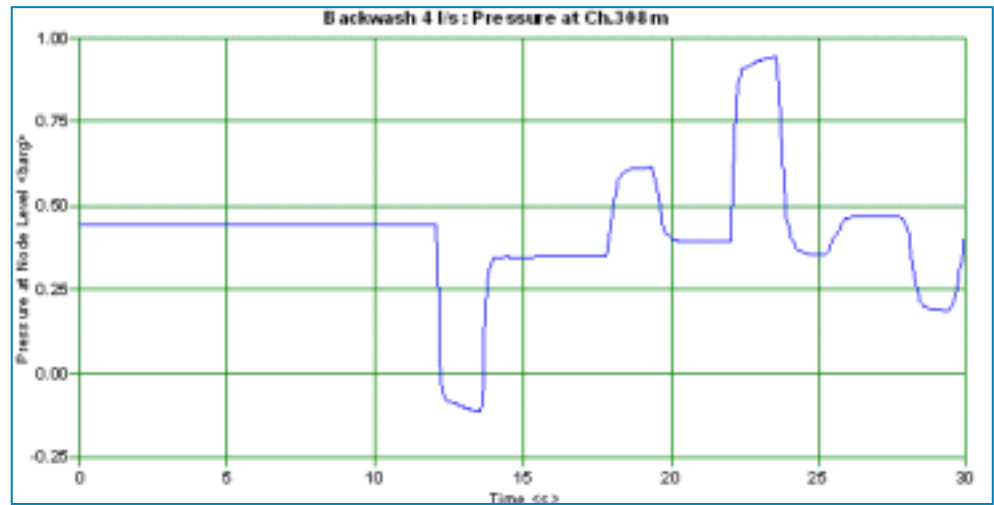
Figure 1: The negative pressure transient at chainage 308m.

Since the onsite investigations lead to the assumption that air was entering the system and the most likely route was through air valves situated at intervals along the suction main, the next stage was to prove this and then propose a cost-effective solution.

Once it could be numerically proven that the negative pressure transients caused the air valve on the suction main to open, the task was then to propose a solution. The simplest and most cost effective way came in the form of a bladder type surge vessel to absorb the rate of change of flow. Furthermore air release valves were fitted to the filter vessels.

From the initial simulation that proved the pressure in the suction main was causing the air valves to open and identify which backwash flow rates were the cause, the model was then modified to include the bladder type surge vessel and predict the optimum size and connection diameters to the existing system. Figures 1 and 2 show the pressure transients at the most critical point before and after the surge vessel is added. The addition of the surge vessel and air release valve on the filters at Broadford has reduced the frequency of the backwash cycle from typically 5 minutes to over 60 minutes and the ensured that clean safe water can be produced

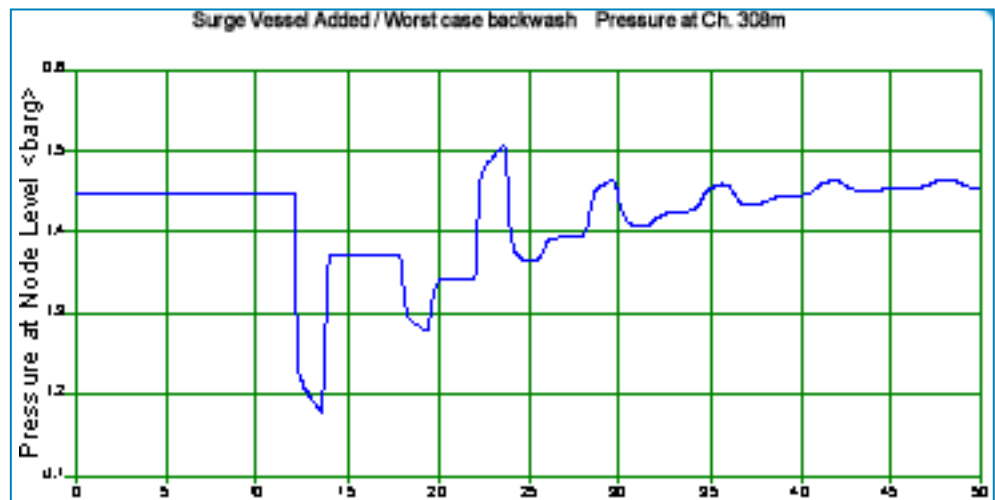
Figure 2: The elimination of negative pressure at a higher backwash flow rate (worst case) for the same point due to the addition of the surge vessel.
